Subject: Visit to Maple Meadow Mine, Fairdale, WV

Investigation of Ground Conditions at the Maple Meadow Mining Company, Maple Meadow Mine  
MSHA ID No. 46-03374

As requested, an investigation was made at the Maple Meadow Mining Company, Maple Meadow Mine on November 5, 1993. The mine has recently experienced coal bursts in the 2167 retreat section.

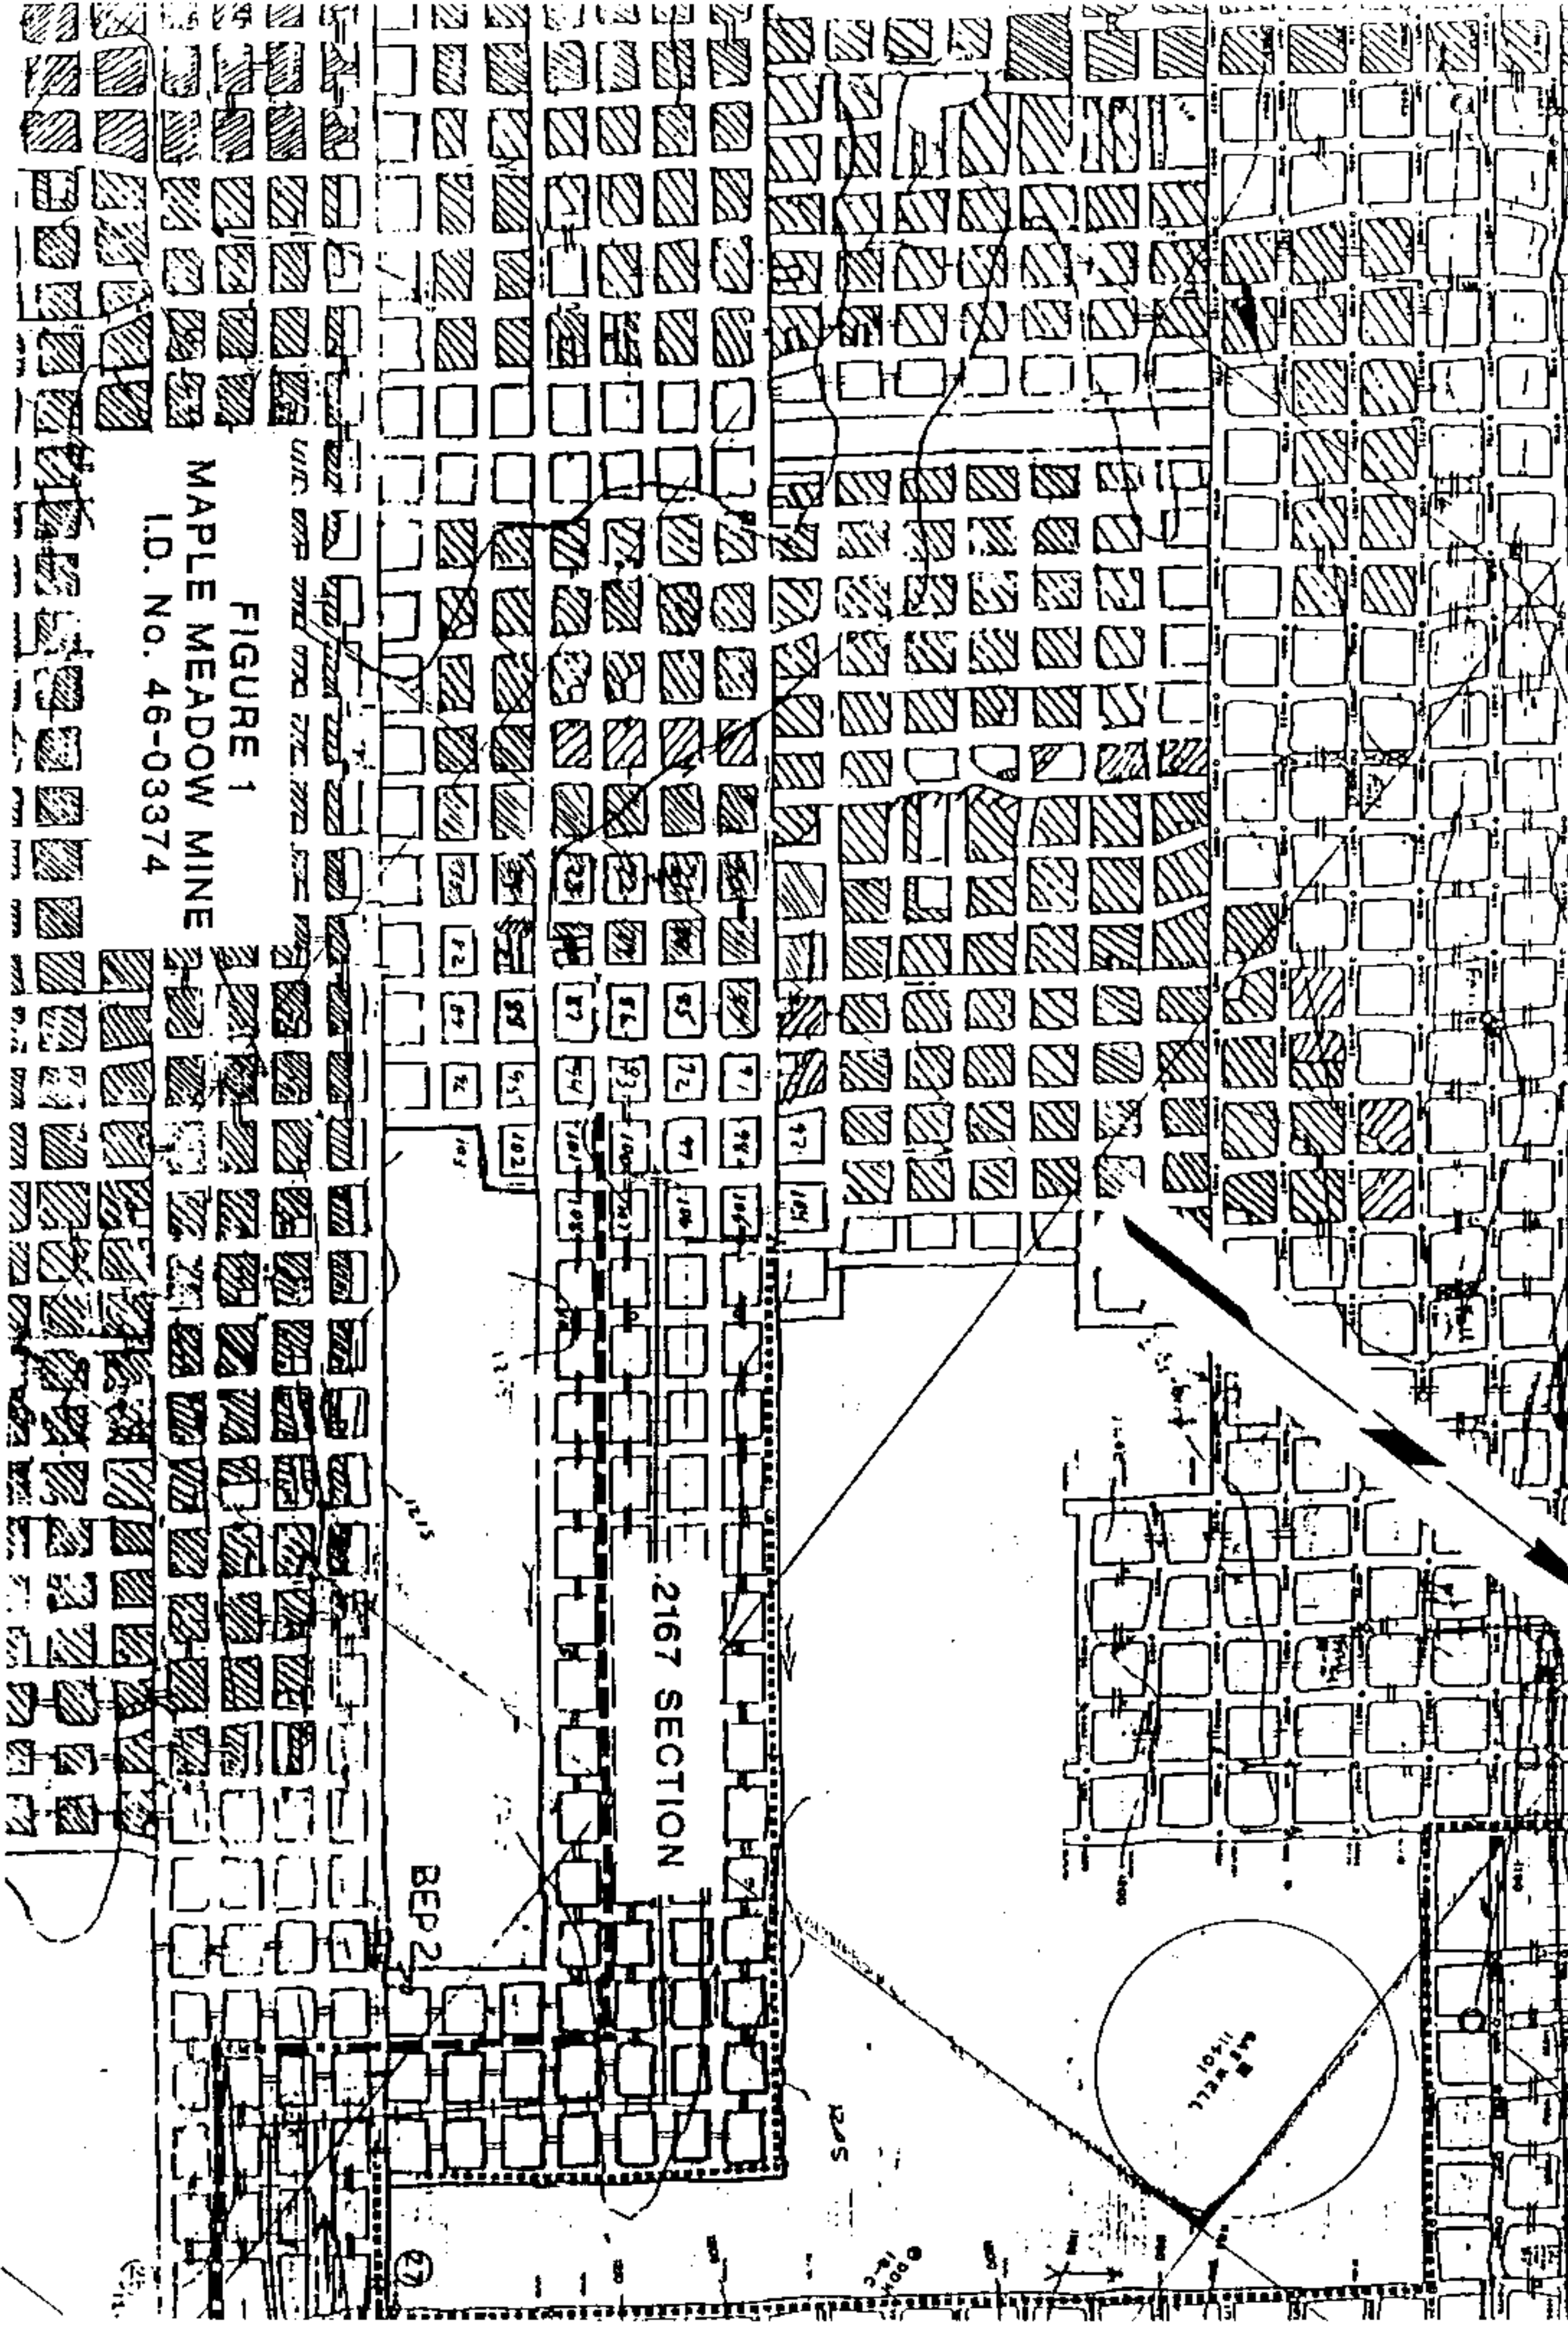
FIGURE 1  
MAPLE MEADOW MINE  
I.D. No. 46-03374

Conditions were examined throughout the face area of the 2167 retreat section (Figure 1). Pillars numbered 84, 78, 79 are shown as completely mined; pillar 80 was split in the crosscut direction with the inby half mined and the outby half still intact. Pillar 81 was split in the entry direction with twinning proceeding left one cut. On development, roof support was provided with 5-ft.-long fully grouted bolts installed on 4-ft. by 4-ft. centers. During retreat mining, roof support is

Pillar sloughing was extreme for three blocks outby the face area with numerous posts set as supplemental support. Generally roof conditions appeared stable except for the crosscut between pillars numbered 91, 92, 93 and pillars numbered 98, 99, 100 where numerous cribs had been set and appeared to be taking weight. Bottom heave was evident in most of the crosscuts within three blocks of the face. The crosscut outby pillars numbered 80, 81, 82 had to be graded for clearance before retreat mining in this area. Observations inby the number 80 and 81 pillars revealed no caving of the roof and that numerous stumps and posts were still intact. Observations inby the number 97 and 104 pillars revealed that caving of the roof appeared to have fallen only approximately 10 ft. high. The rib of the number 89 pillar facing the 88 pillar and the right outby corner of the 82 pillar showed evidence of bursting. The coal in these areas of the pillars was dislodged 3-ft. to 5-ft. and appeared crumbled and highly fractured. Conditions improved significantly three blocks outby the face as was evident by the lack of sloughing of the ribs and the lack of weight on the occasional post or crib.

- o Mining of the barrier to the left of the number 1 entry of the 2167 section should be minimized. Mining only for the purpose of connecting ventilation is advised.
- o Mining to the right of the number 5 entry with the proposed system (four entries developed and then retreated back to the number 5 entry), coupled with the first recommendation of not mining the barrier to the left would still create a situation with gob on two sides of the active pillar line in the 2167 section. It is recommended that a mining plan be created and implemented whereby only one gob exists during retreat mining in the 2167 section.
